SIO Shipyard Representative Bi-Weekly Progress Report		
Project: AGOR 28	Contract No.: N00014-12-C-0305	Shipyard: Dakota Creek Industries
Prepared by: Paul D. Bueren Scripps Institution of Oceanography (SIO) 297 Rosecrans St. San Diego, CA 98106	Date: 18 May 2016	Program Officer: Robert (Tim) Schnoor Office of Naval Research 875 Randolph St ONR 321 Arlington, VA 22203-1995
Distribution Statement A: Approved for public release; distribution unlimited.		Report No. A002.099

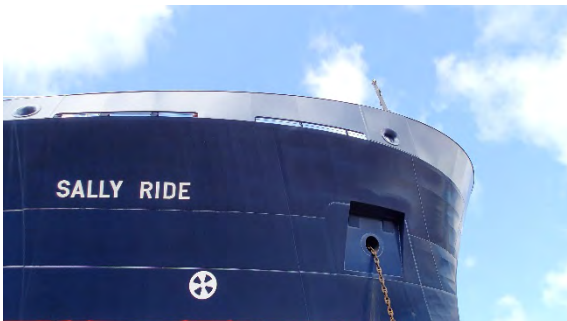
- Uncontaminated Sea Chest – Work completed. Welds and piping inspected and tested.
- Anchor Pocket Shims – Work completed and anchors shipped.

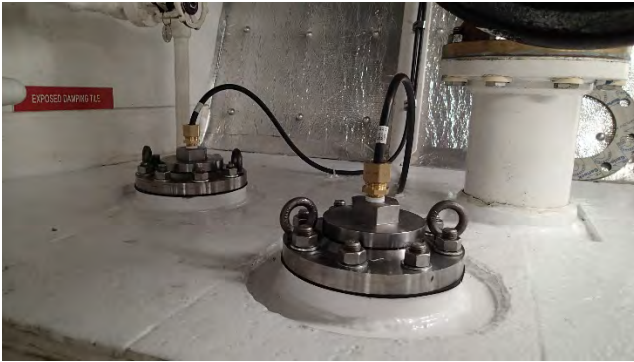
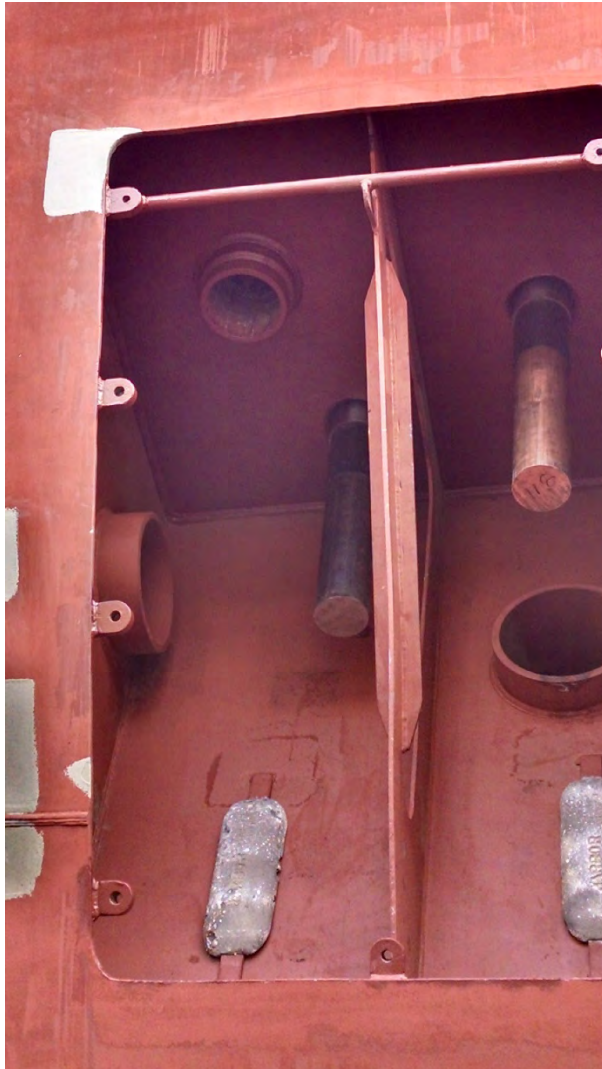
- Anti-Fouling System – DCI installed the controls and anodes for the Port, Starboard and Fire Pump sea chests. All penetrations and welds inspected and tested with ABS in attendance.

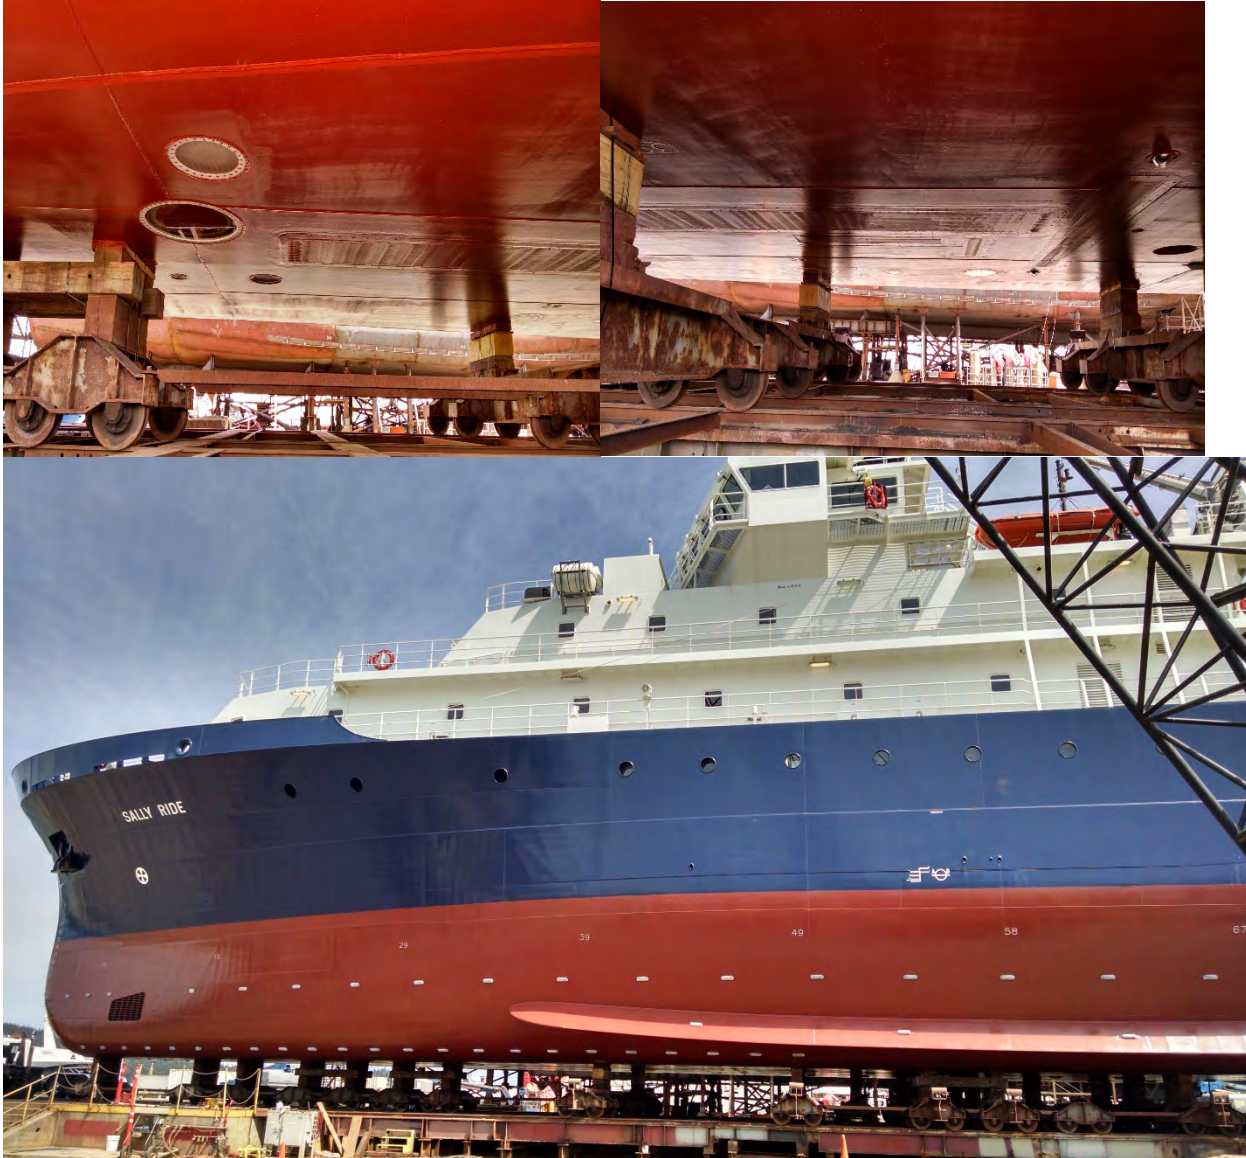
Launch scheduled for Tuesday. Phase III work requiring ship out of the water completed. Pleased to note all docking blocks are all flat topped. Ship does not require complicated double angle side blocks. Docking plan seems to be very simple. This should simplify future drydockings. Paint looking good. New hull sensors flush to hull and where required nicely faired in
